# Lime-Stabilized Native Soil As A Base Course For Light Aircraft Pavement.

R. B. BROWNIE

April 1981

Final Report

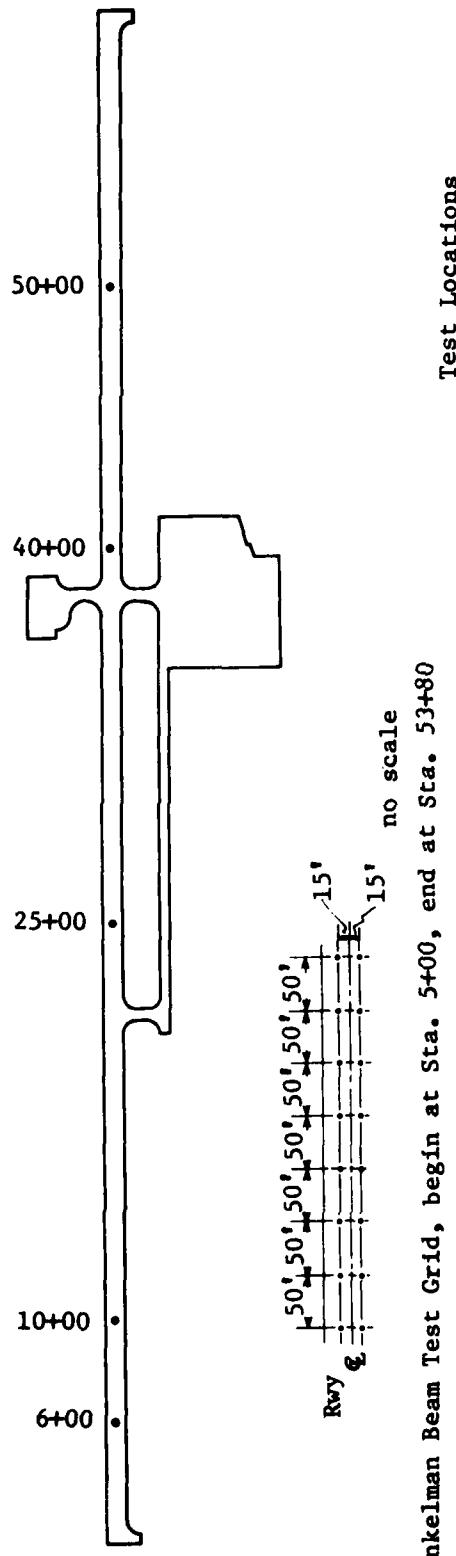
Figure 2. Big Bear City Airport - California - testing layout (no scale).

Big Bear Airport, CA. Big Bear Airport is also located in San Bernardino County and is operated by the County Department of Airports. It consists of one runway, 7-25 and associated taxiways and ramps. Runway 7-25 is 5,850 feet long and is at an elevation of 6,748 feet above sea level. The pavements evaluated in this report were constructed in 1973 with a design section of 3.0 inches of asphaltic concrete, 11.0 inches lime-stabilized base course, and 24 inches of compacted subgrade soil. Additional taxiway and ramp pavements were under construction in 1978 using the same design section, however, these sections are not included in the evaluation. The pavements evaluated are shown in Figure 2.

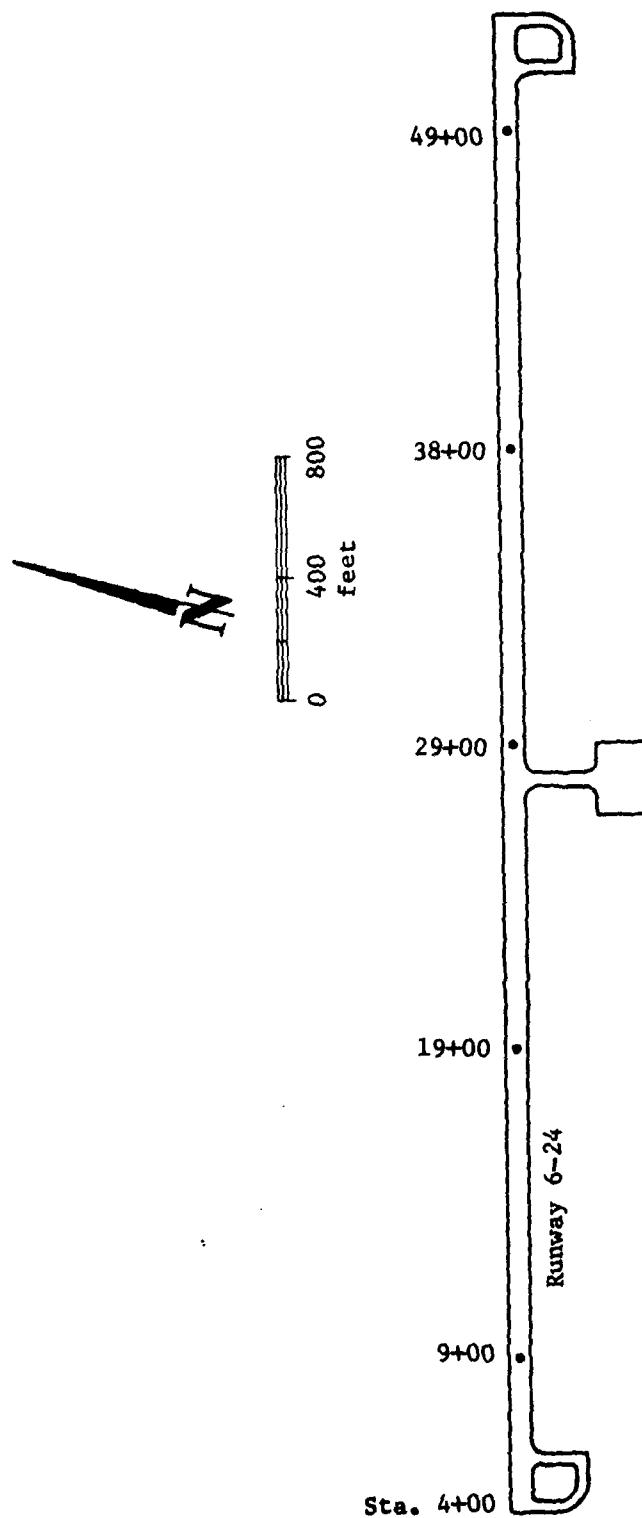
Figure 3. Payson Airport test locations (no scale).

Payson, AZ. Payson Airport is located in Gila county approximately 75 miles northeast of Phoenix. The airport consists of 4,900 foot long runway 6-24, aircraft turnarounds at each end, and an aircraft parking apron. The airport elevation is 5,195 feet. All pavements at Payson Airport were constructed in 1975 using a design section of 2.0 inches of asphaltic concrete, 12.0 inches of lime-stabilized soil over variable thickness of compacted subgrade. The layout of Payson Airport is shown in Figure 3.

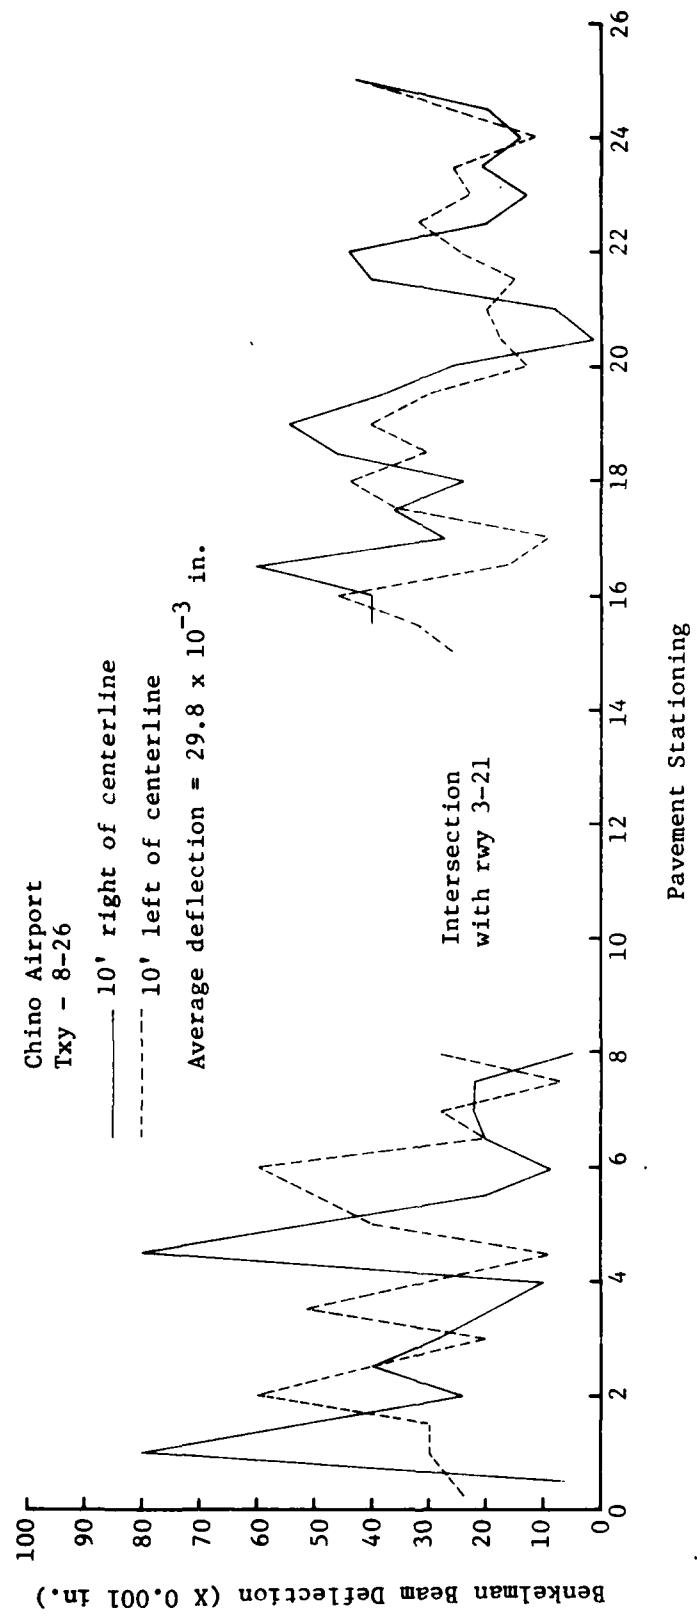
The data from the surface deflection measurements were analyzed and are summarized in Table 4. The data are also plotted in Figures 14 through 18. The plots show a profile of deflection variation longitudinally along the pavement surface. Interpretation of the data supports the variability found in lime-stabilized layer thickness and compressive strength. Coefficients of variability (CV) for the Benkelman Beam data range from 49.0 to 83.0 percent. Yoder and Witczak (Ref 5) give data for deflection measurements on 259 varied highway sections showing a CV range of 5.6 to 55.5 percent. The lime-stabilized section with the lowest CV in Chino Airport, Taxiway 3-21, stations 30+00 to 60+00 with a CV of 49.0 percent and Big Bear Airport was the highest at 83.0 percent. The high CV for Big Bear is partially attributed to the distressed section from station 5+50 to 8+50 which was removed and replaced in Sep 1978. Deleting the test data from that area, however, only lowers the Big Bear CV to 68.4 percent, still very high compared to highway pavement sections. The primary causes of variability in the lime-stabilized sections are felt to be non-uniform mixing of lime and variable thickness of stabilized layers.

Figure 15. Benkelman beam deflections, Taxiway 8-26, Chino Airport.

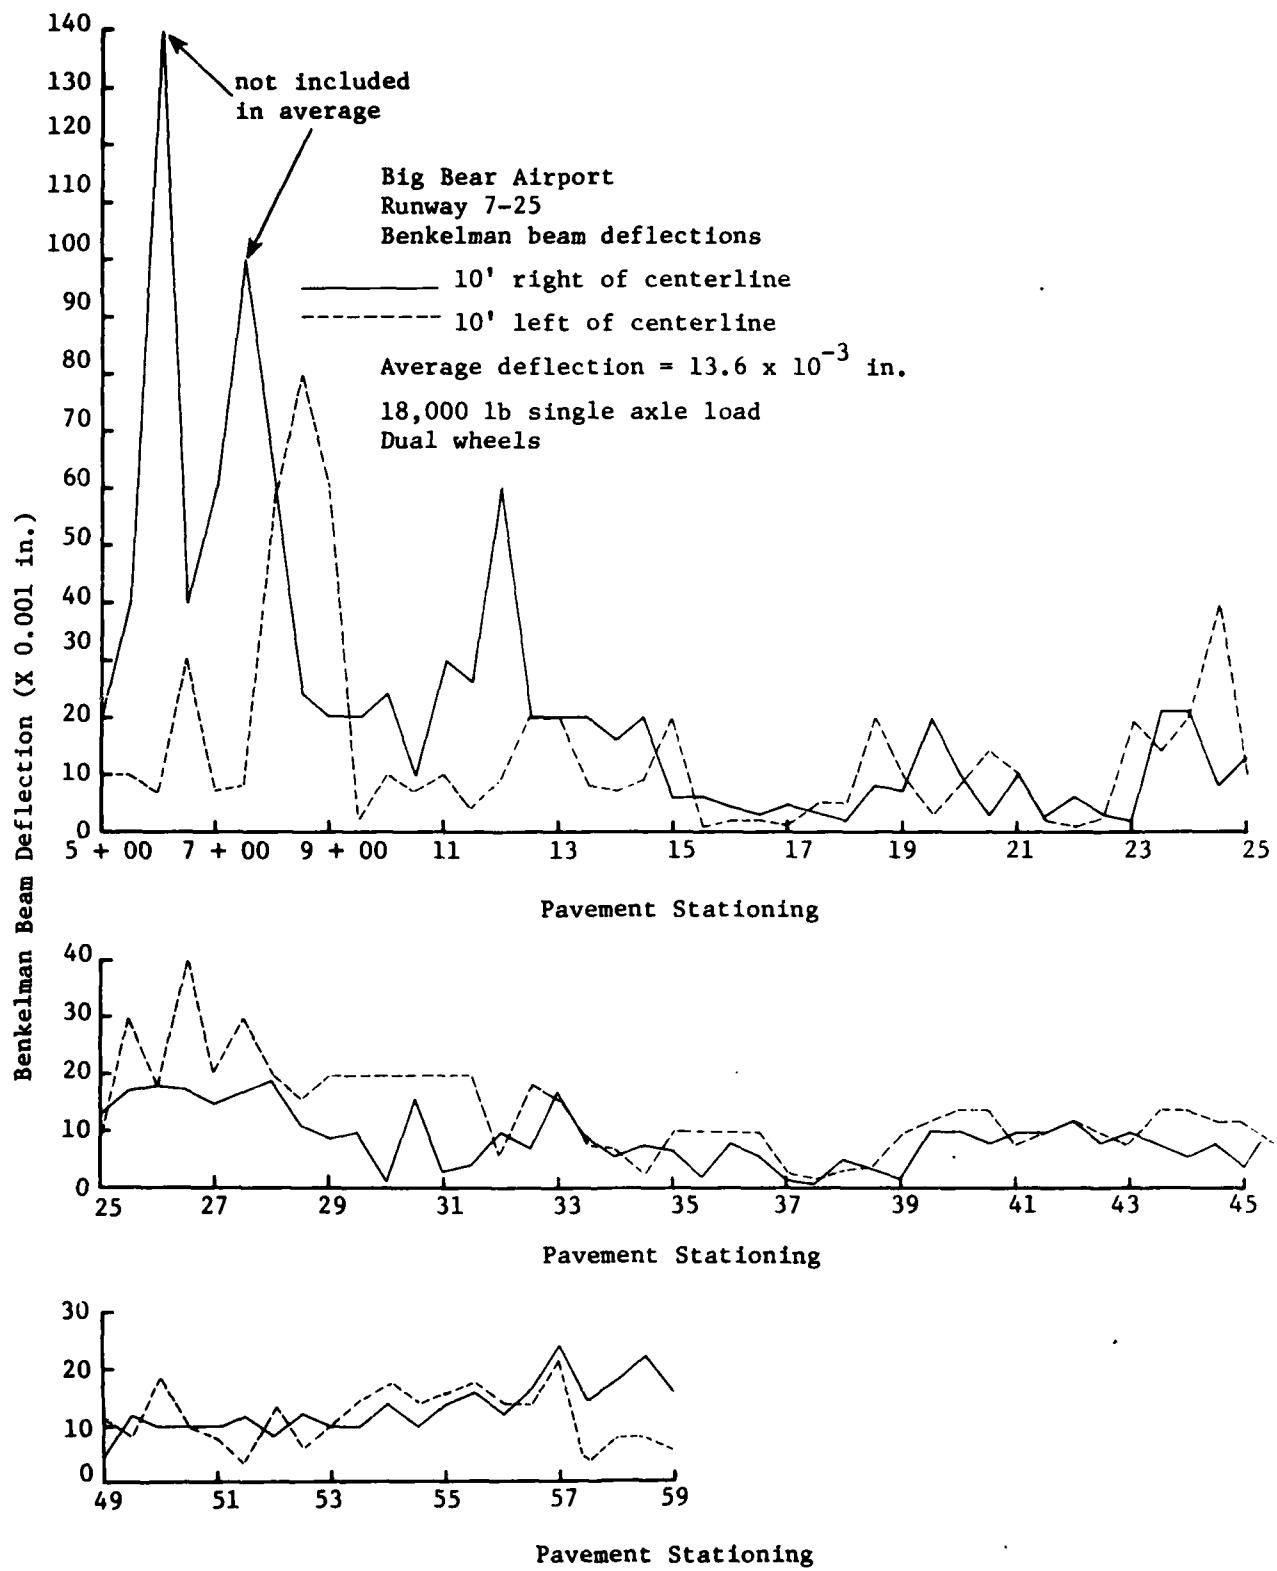
Figure 16. Benkelman beam deflections, Runway 7-25, Big Bear Airport.
